STATE OF CALIFORNIA
DEPARTMENT OF TRANSPORTATION
DIVISION OF NEW TECHNOLOGY,
MATERIALS AND RESEARCH
OFFICE OF TRANSPORTATION MATERIALS AND RESEARCH

VEHICLE CRASH TESTS OF A
MOVABLE CONCRETE BARRIER

1. Report No. FHWA/CA/TL-89/08		2. Government Accession No.		3. Recipient's Catalog No.	
4. Title and Subtitle VEHICLE CRASH TESTS OF A MOVABLE CONCRETE BARRIER				5. Report Date June 1989

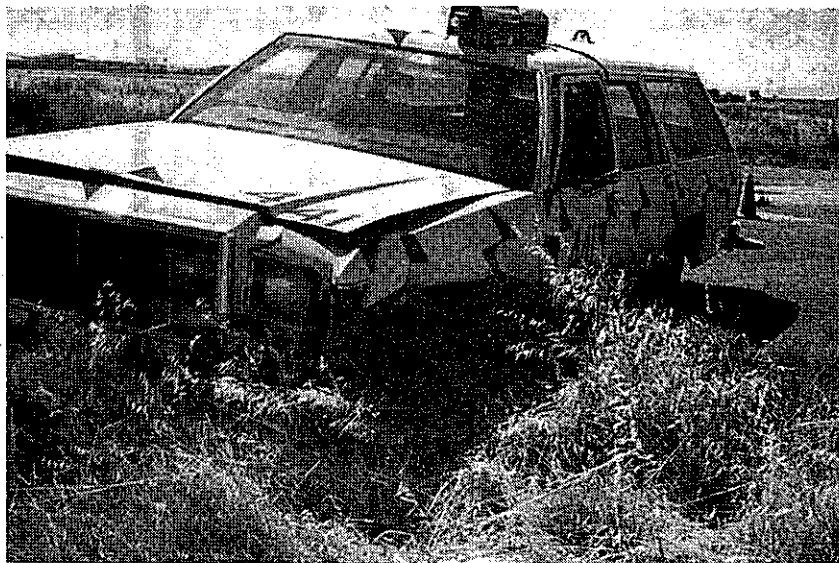
FIGURE 13
TEST 441 VEHICLE DAMAGE

Overall view of Damaged Vehicle.
Crushed left side of the bumper and fender.

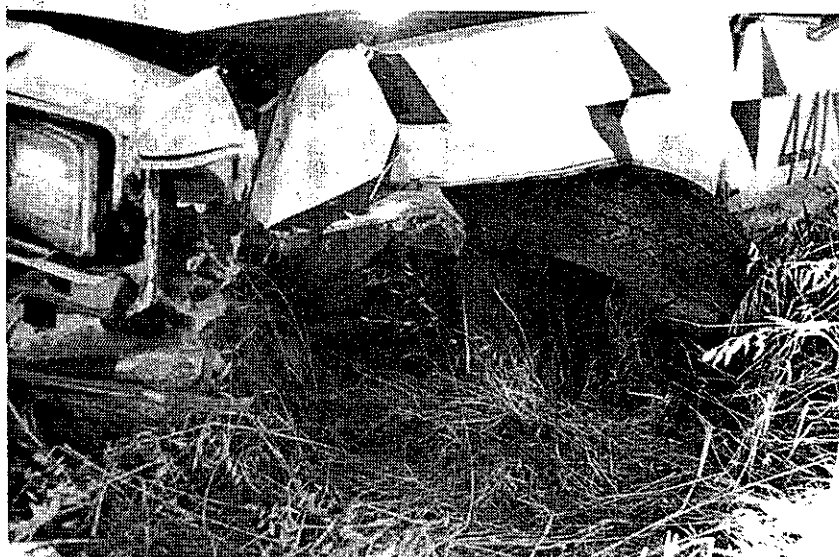
Deformed left front wheel and torn tire.

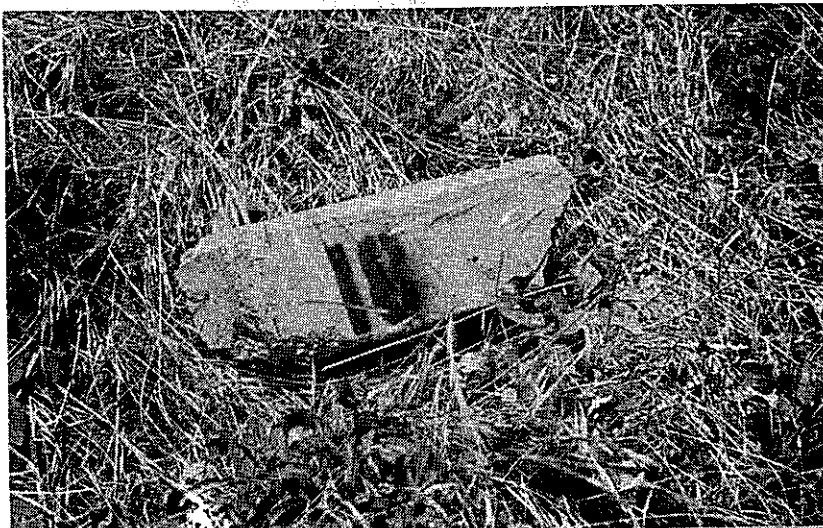
Barrier Concrete
Chunk

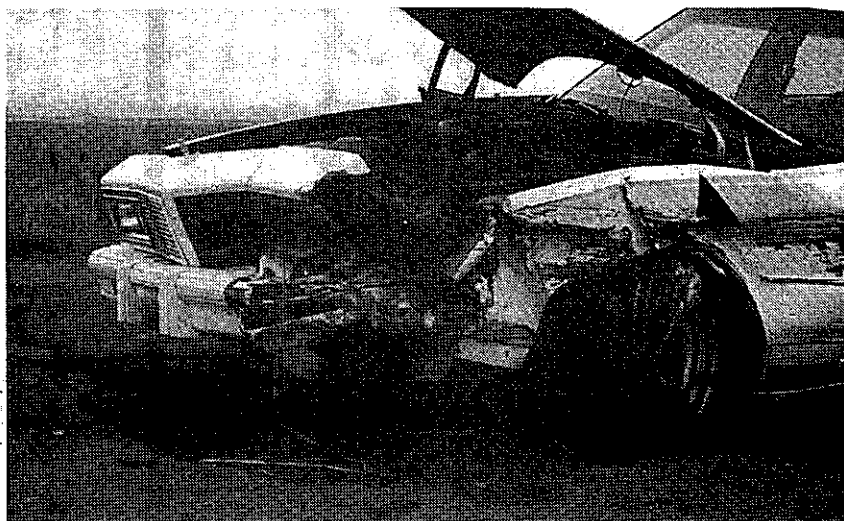
FIGURE 28 (Continued). TEST 443 VEHICLE DAMAGE

Severe Damage to Left Front Corner of Test Vehicle

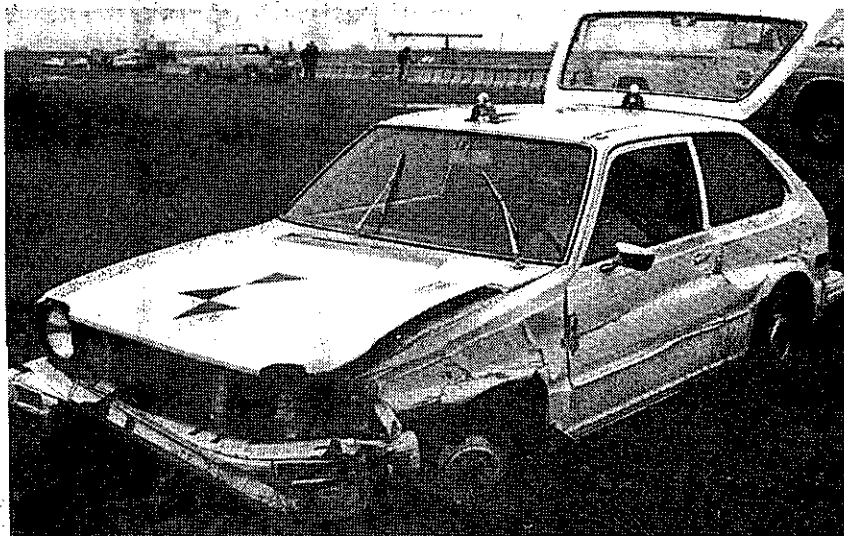
FIGURE 36. TEST 444 VEHICLE DAMAGE

Damage to Left Front Side of Test Car.

The first part of the vehicle to contact the barrier was the left side of the front bumper. Thus, immediately after impact, the left side of the bumper and the entire front fender including the left headlight were seriously damaged (Figure 36). The left side of the car was scraped and crinkled. The left, front door was scraped, crinkled, jammed and partially opened. The left side of the hood was jammed and the hood could not be opened. The radiator was intact but the engine was moved to the right. The left front tire was flattened and its movement restricted.

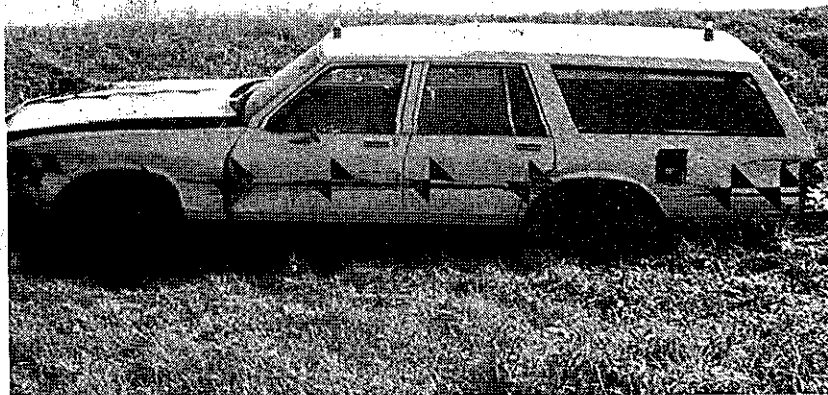
FIGURE 43. TEST 445 VEHICLE DAMAGE

Damage to Left Side of Car.

The first part on the vehicle to contact the barrier was the left side of the front bumper. Thus, immediately after impact, the left side of the bumper and the entire front fender including the left headlight were seriously damaged (Figure 43). The left side of the car was scraped and crinkled. The left doors were crushed and jammed. The left front door post was deformed as a result of the door damage. The hood was displaced to the left and could not be opened. The radiator and the engine were intact and unmoved. Both left tires were flattened and their movement was restricted.

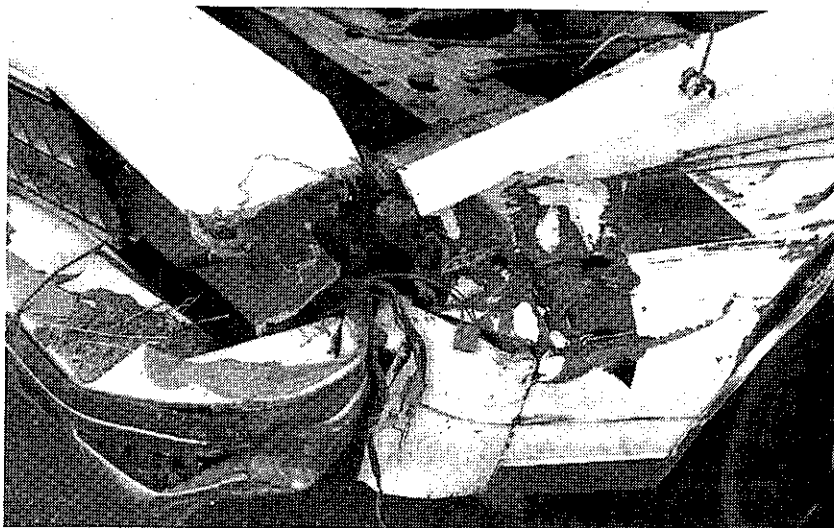
Close-up View of
Left Front
Corner.

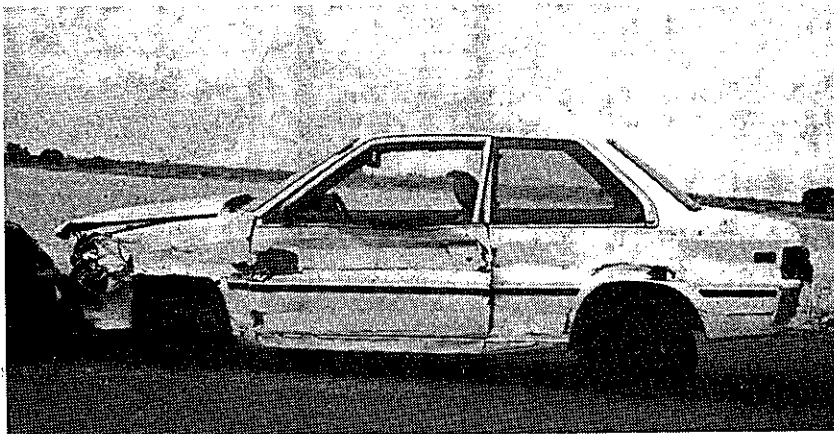
FIGURE 51. TEST 446 VEHICLE DAMAGE

Damage to Car
Left Side-Scrapes
and Wrinkles.

The first part of the vehicle to contact the barrier was the left side of the front bumper. Thus, immediately after impact, the left side of the bumper was damaged. The left headlight and taillight were broken. The left front fender was severely crushed and the left rear fender was crinkled (Figure 51). The left front door was crushed and jammed. It was bent outward at the bottom of the window by the dummy. The left front frame member under the engine was slightly bent. The hood was opened and its left front corner was crushed. The radiator was pushed back to the fan. Both left and right front tires were flattened and wheel movement was restricted.

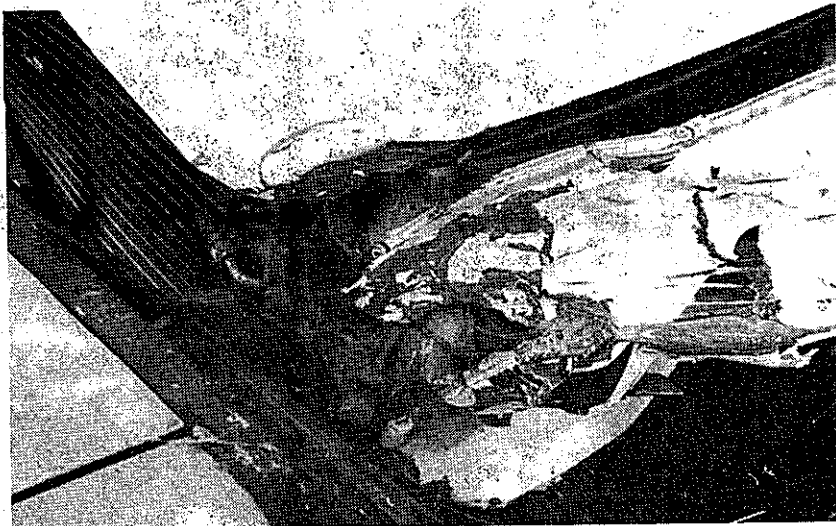
Close-up View of
Damaged Left
Front Corner.

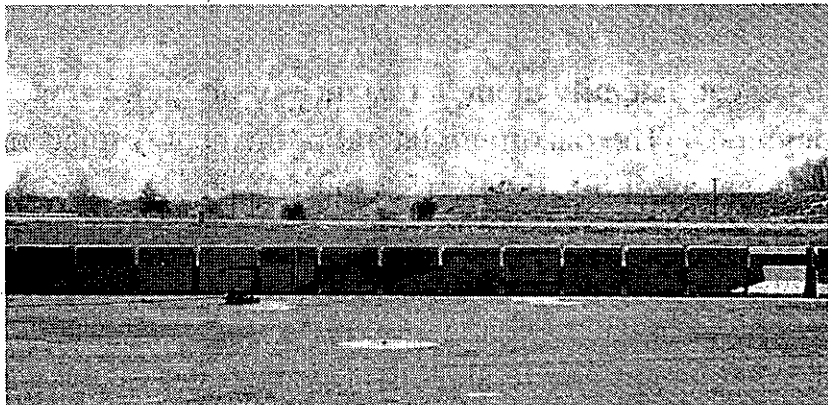
FIGURE 52. TEST 446 BARRIER DAMAGE

Tire and Wheel Scuffs on Barrier Impacted Segments.

There was no evidence of any structural failure of the barrier. No visible cracks were detected. The only damage imparted to the barrier was a few scrapes and tire marks (Figure 52).
